White Paper

# 24 Month Follow Up: Vapor Corrosion Inhibitors Maintain Stronger Corrosion Protection Than 98% Purity Nitrogen

December, 2025

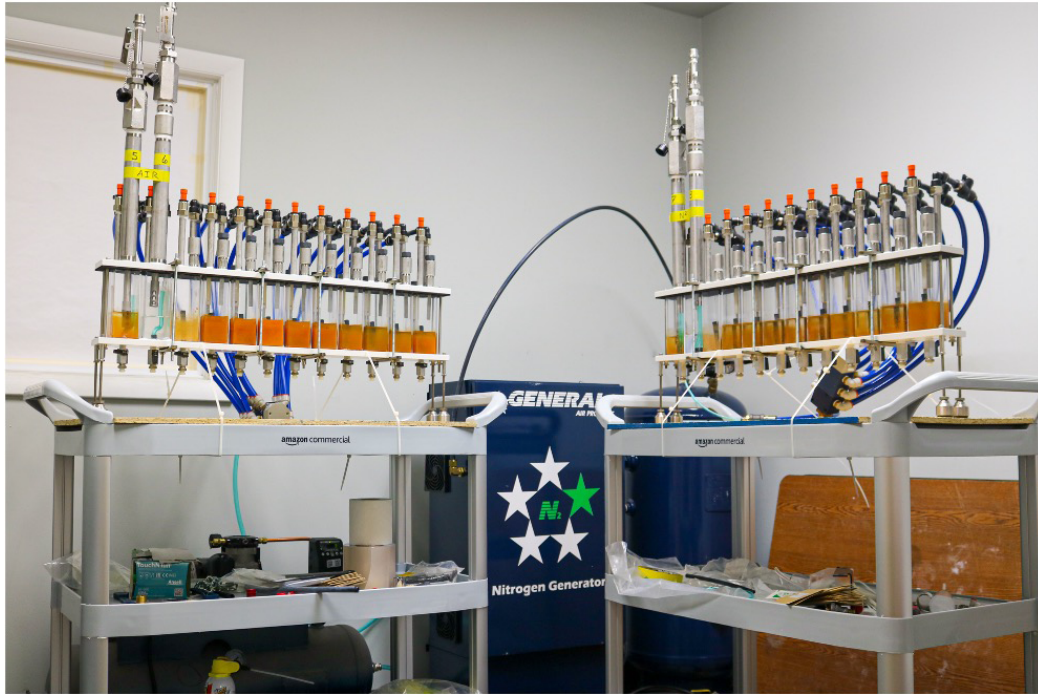
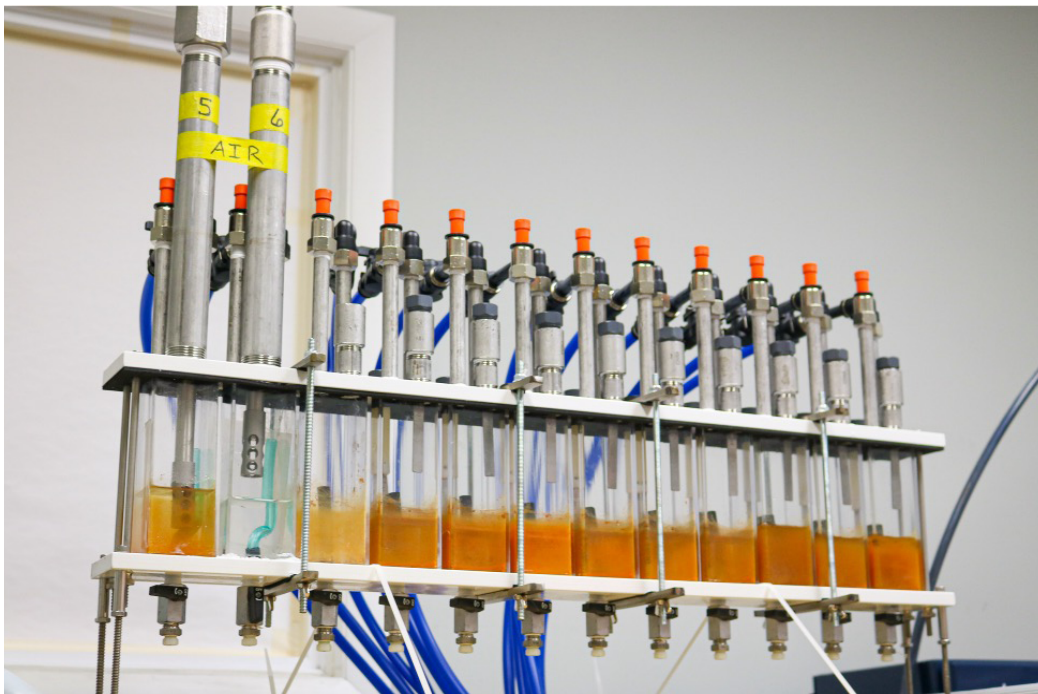
12 chambers partially filled with water where coupons made from C1018 carbon steel are submerged.

Each test station contains 12 chambers partially filled with water to simulate real-world conditions where water accumulates in sprinkler piping. Coupons made from C1018 carbon steel are submerged and exposed to the vapor phase in each chamber. Corrosion is measured using mass loss, visual inspection, and electrical resistance (ER) probes at six-month intervals.

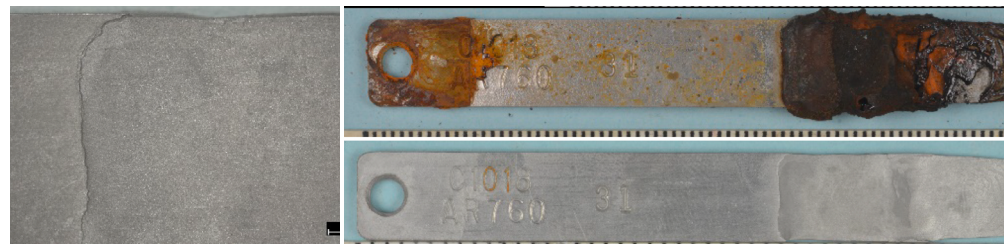
**Compressed Air**

*Depicted images were taken before and after cleansing.*

- » Compressed air coupons displayed extensive corrosion and material degradation
- » Nitrogen coupons showed some improvement but still exhibited localized corrosion.
- » VCI coupons maintained their integrity, with only superficial pitting observed in some cases.
