White Paper

# 24 Month Follow Up: Vapor Corrosion Inhibitors Maintain Stronger Corrosion Protection Than 98% Purity Nitrogen

December, 2025

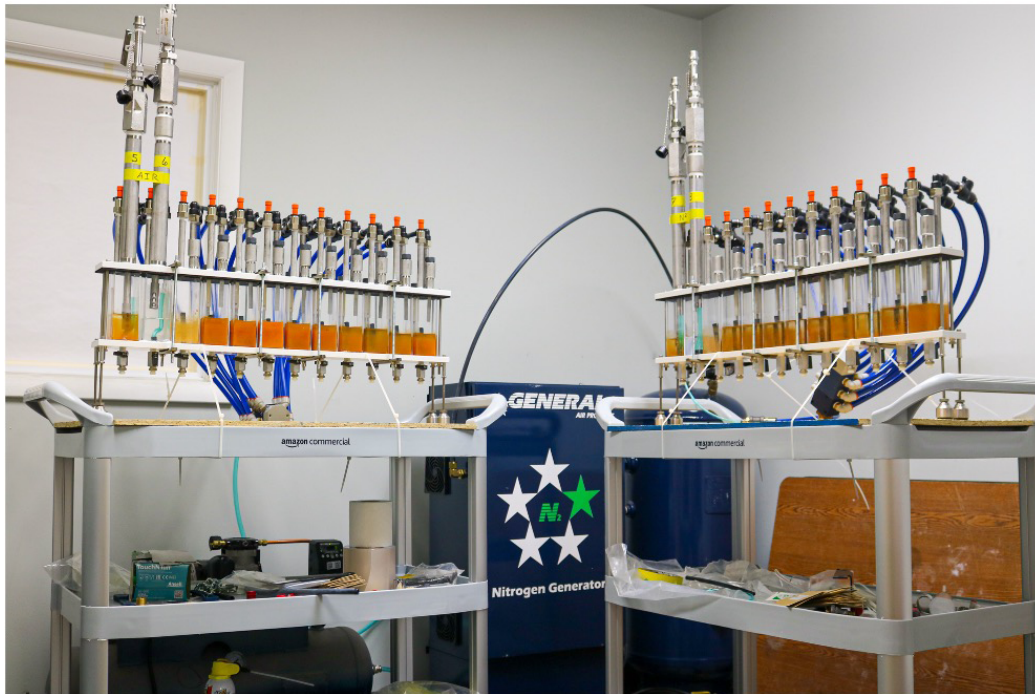
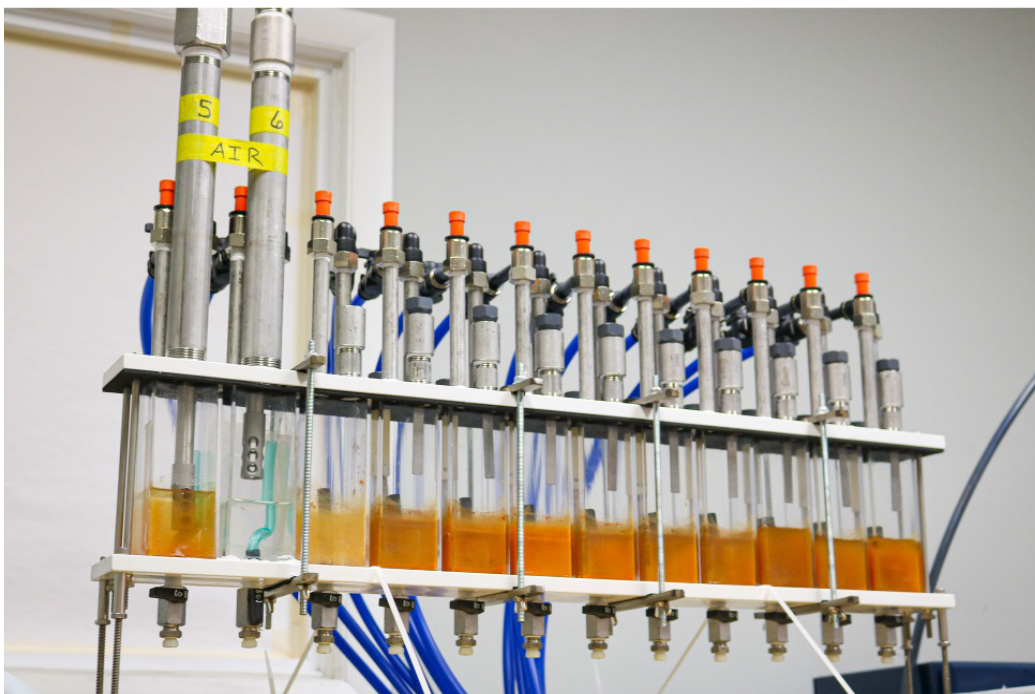
12 chambers partially filled with water where coupons made from C1018 carbon steel are submerged.

Each test station contains 12 chambers partially filled with water to simulate real-world conditions where water accumulates in sprinkler piping. Coupons made from C1018 carbon steel are submerged and exposed to the vapor phase in each chamber. Corrosion is measured using mass loss, visual inspection, and electrical resistance (ER) probes at six-month intervals.

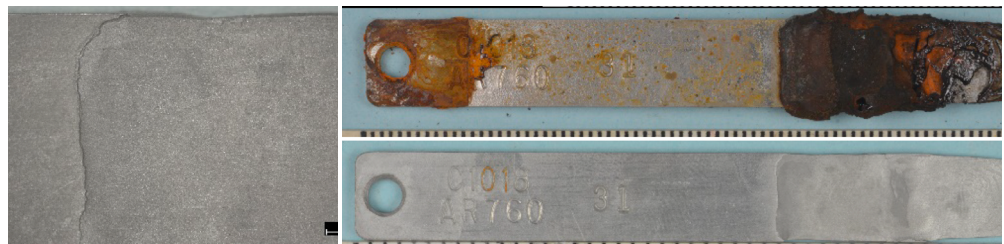
**Compressed Air**

*Depicted images were taken before and after cleansing.*

- » **Compressed Air:** This remained the harshest environment, with low-position coupons developing significant pitting and an adjusted metal loss of 21.83 mils after 24 months.
- » **98% Purity Nitrogen:** While noticeably less corrosive than air, nitrogen still allowed measurable deterioration, resulting in 4.48 mils of metal loss.
- » **VCIs:** VCI-treated samples showed exceptional stability, experiencing only 0.19 mils of metal loss, indicating minimal corrosion throughout the test period.

- » Compressed air coupons displayed extensive corrosion and material degradation
- » Nitrogen coupons showed some improvement but still exhibited localized corrosion.
- » VCI coupons maintained their integrity, with only superficial pitting observed in some cases.
